RENOVATION STUDY

INB Performing Arts Center

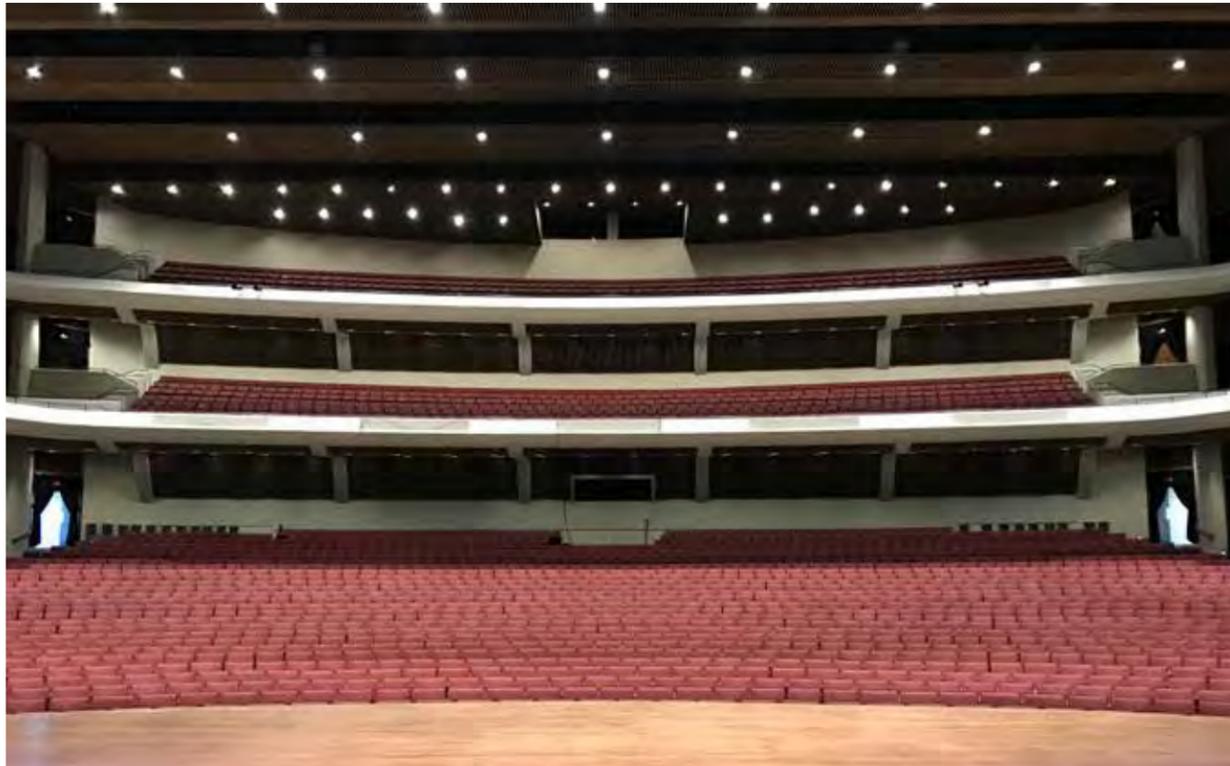
Existing Auditorium

Existing floor return air grilles located along the south exterior wall will need to be replaced within the new floor. Pipe in the tunnel below will require temporary pipe supports when the floor is removed and reinstalled. It is assumed that the floor will be constructed in phases so that the pipe does not have to be completely removed and reinstalled. After completion of new floor, provide new pipe hangers with vibration isolation similar to existing to new overhead structure.

Modifications to existing floor slab may impact the existing electrical services located below at the tunnel ceiling. Services include an electrical busway which serves as the main electrical service to the convention center side of the campus. Provide temporary support of existing electrical busway and electrical conduits during this phase of work.

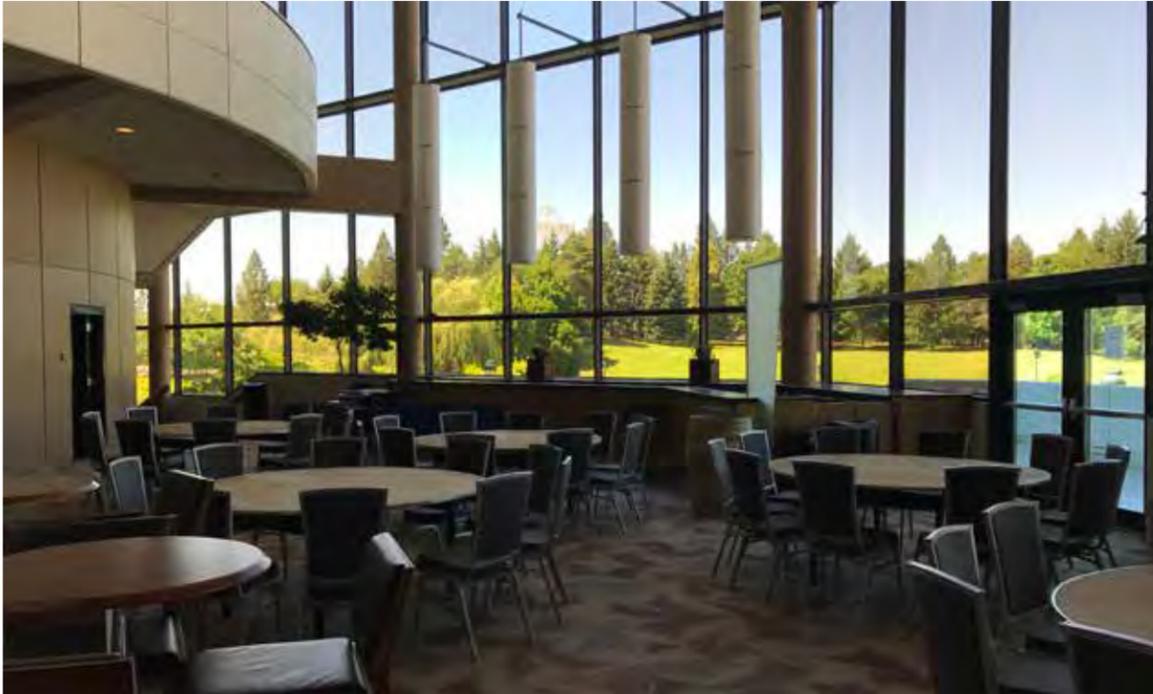
Existing Upper Lobby

The existing paging speakers in the lobby are located above the balconies and do not effectively distribute audio throughout the lobby. Replacement of the speakers and addition of speakers above the main lobby area are needed for uniform coverage.

Replace supply and return diffusers in ceiling system. Reset sprinkler heads in new ceilings. Replace floor return grilles not covered in scope items for the auditorium accessibility and music room improvements.

Replace existing lighting with LED type, including controls for automated daylight harvesting. Provide architectural lighting improvements for Lobby.

Replacement of existing ceiling mount fire alarm devices is recommended while other work is occurring at the lobby ceiling.

Replace existing wall mounted devices and cover plates.

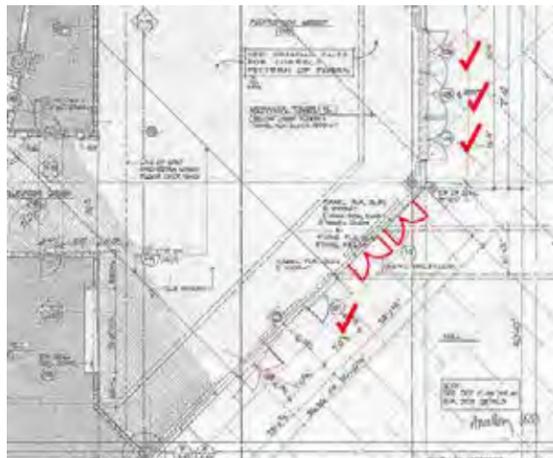
- Entry
 - A total of six double doors, two bays is ideal. The two pairs currently farthest south do not function well.

- Would like to get electrical floor boxes in place for the metal detectors. Right now, they have some cords running across the floor and clumped up in between the detectors. They also have a table off to the side that has tons of cords underneath it.
- The tables stored against the curtain wall, directly to the right as you come in the entry are used for bag checking and dividing lines to the doors at nearly every event.
- More space!
- Exits
 - Northwest and southwest exit doors are chained closed so people won't just be able to let others in.
- Would prefer them either inside the Opera House lobby or just outside the doors to the north, maybe under the stair somehow.

- The main line to enter never wraps that way, so staying north of the main entry doors should work. The only way the line can safely run is southeast from the entry doors toward Division and that is what it always seems to do even if they try to reposition it.
